NAUGATUCK RIVER BASIN

MORRIS, CONNECTICUT

PITCH RESERVOIR DAM CT 00474

PHASE I INSPECTION REPORT
NATIONAL DAM INSPECTION PROGRAM

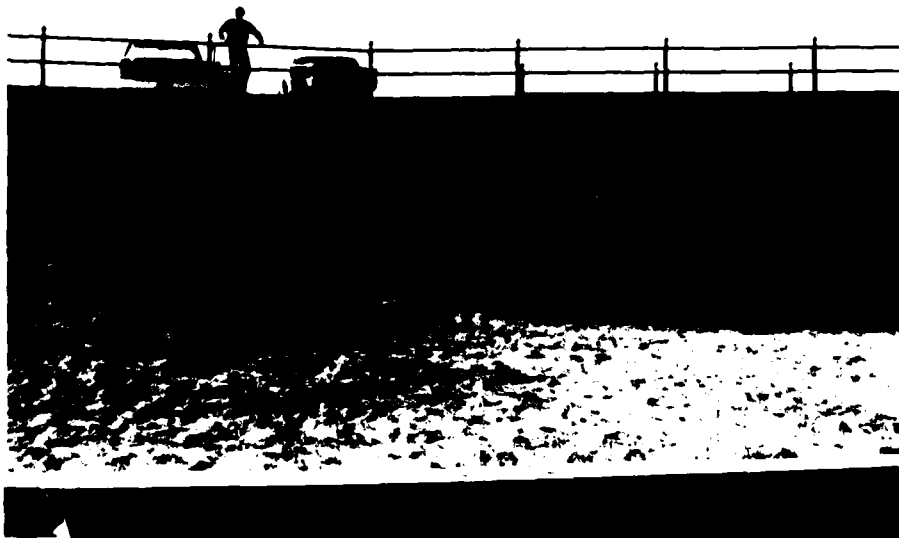
According to the design drawings, the concrete section and about 800 feet of the earthen section is founded on bedrock. The appearance of bedrock outcrops at several locations downstream and adjacent to the spillway is consistent with the design drawings in this respect. The only indication of seepage was found in the concrete section where efflorescence was observed in joints as shown in Photo 10.

PHOTO NO. 10 - Looking toward concrete section of dam from left (east) side of spillway training wall.

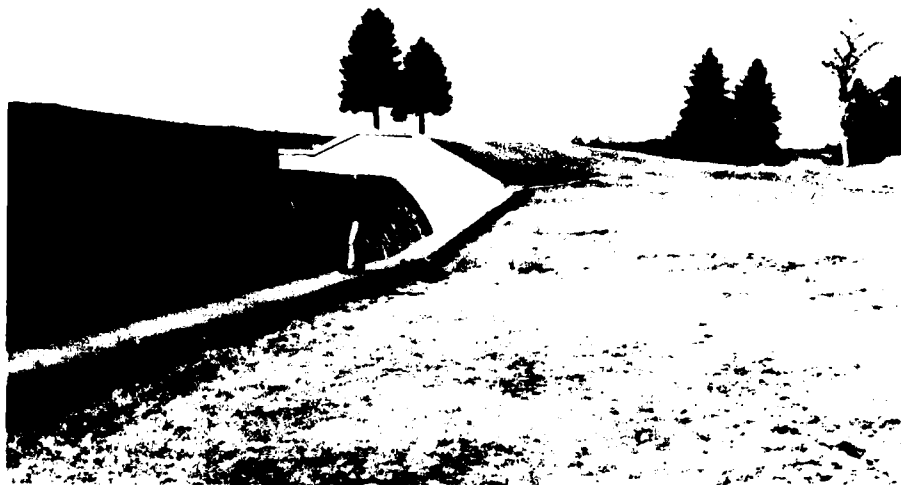
The spillway structure, shown in Photo 11 consists of an ogee-shaped concrete weir 150 feet long and two training walls. The concrete spillway surface is in good condition.

PHOTO NO. 11 - Looking upstream along spillway channel
from left (east) side of spillway training wall.
